7.3.0 Water Hammer At San Onofre

7.3.3 San Onofre Water Hammer Incident

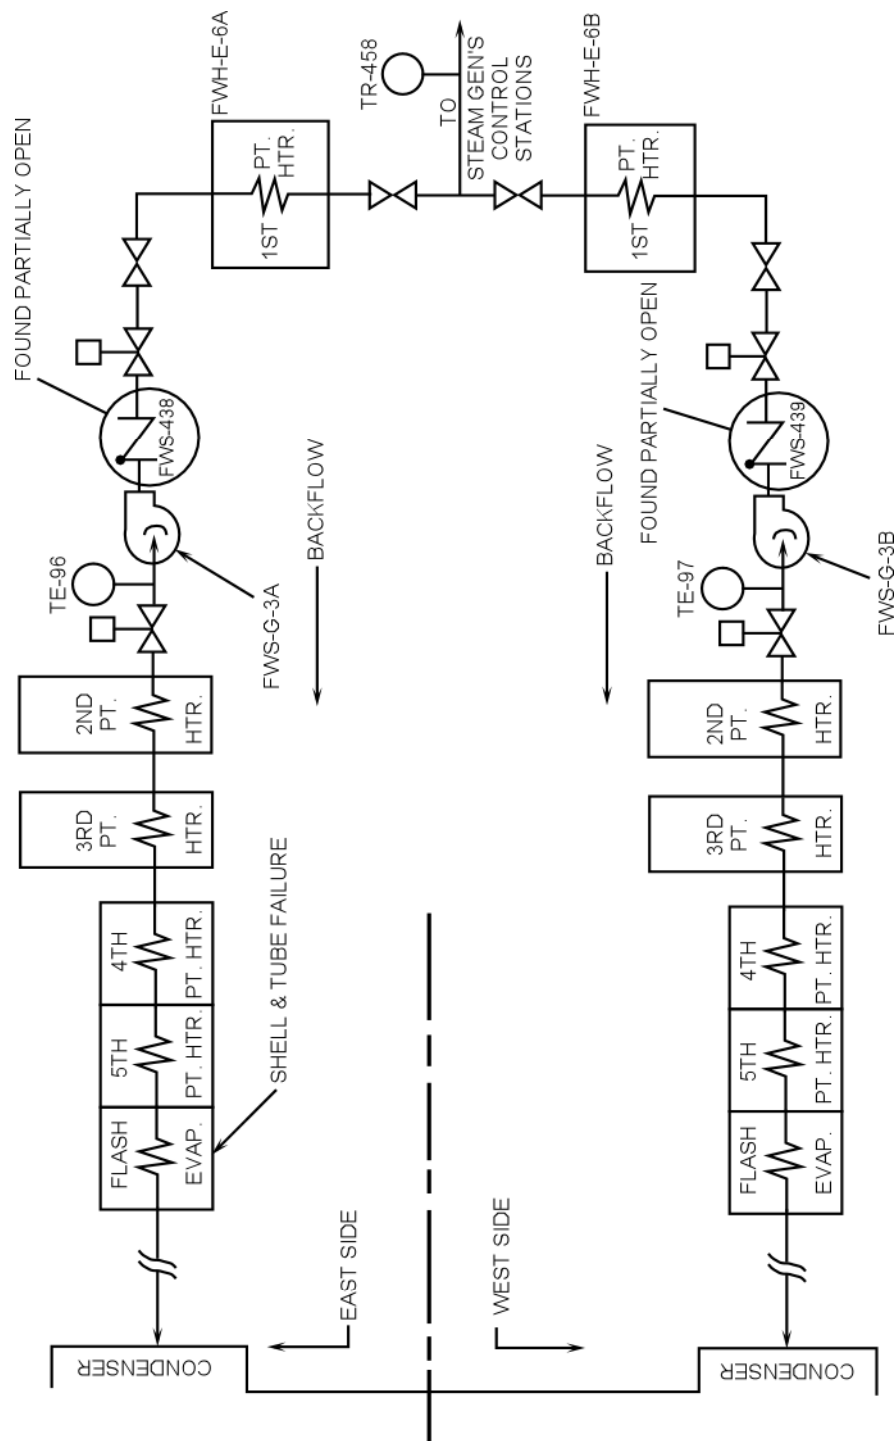
Figure 7.3-6 SONGS-1 Feedwater Flow Diagram

The plant conditions at SONGS-1 which led to a steam condensation-induced water hammer included the voiding of long horizontal lengths of feedwater lines, which allowed the backflow of steam from all steam generators before operators isolated the FW lines (by closing motor-operated valves MOV-20, 21, and 22), and the subsequent refilling of the FW lines with relatively cold (i.e., less than 100°F) AFW. Figures 7.3-3, 7.3-4, 7.3-5, 7.3-6, 7.3-7 and 7.3-8 illustrate the flowpaths, valves and other equipment affected by this water hammer.

The gross failure of upstream check valves, which permitted water to drain from the feedwater lines and be replaced with steam, was the underlying cause for water hammer. Leaky check valves have been previously cited in reports of other water hammer occurrences. Five check valves are known to have been failed during the SONGS-1 event.

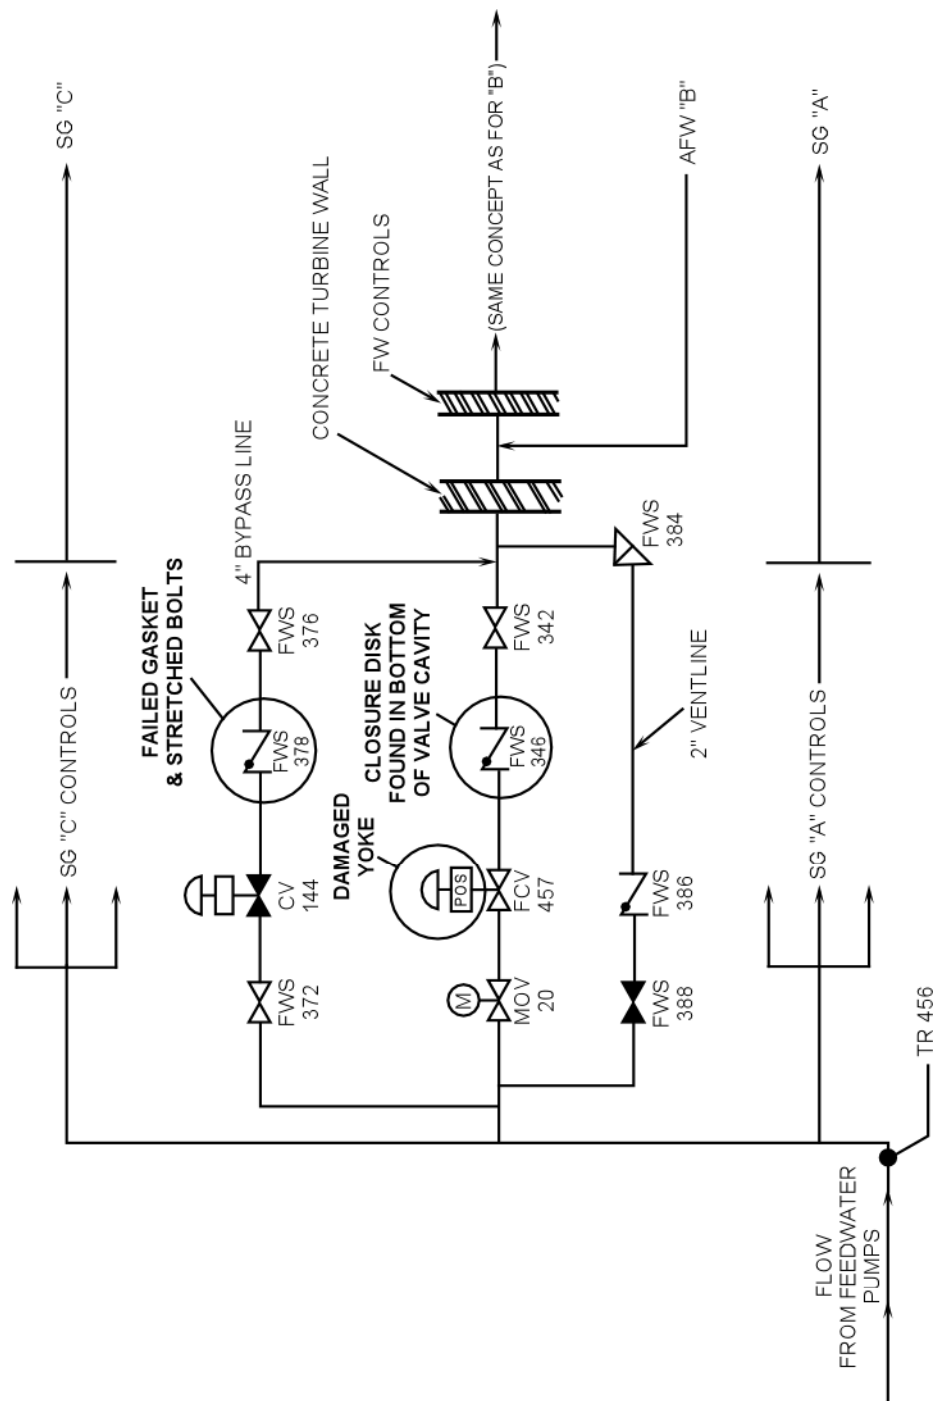
Figure 7.3-7 SONGS-1 Loop B Steam Generator Flow Control Station

Figure 7.3-11 shows the typical internal arrangement of a swing check valve. The water hammer originating in the feedwater line within the containment building generated a water slug which transmitted a pressure wave upstream to the loop B flow control station. Check valves FWS-346 and FWS-378, downstream of the control valves, were designed to prevent backflow, although post-event inspection revealed that the closure disk for FWS-346 (see Figure 7.3-12) was lying in the bottom of the valve chamber. Thus, any closed valve upstream of the check valve would be subjected to the water hammer loads. In addition to check valve FWS-378, flow control valve FCV-457 and motor-operated valve MOV-20 were subjected to the water hammer loads, because they had been closed by operators following the emergency operating procedures.

Because check valve FWS-378 was intact and operational, it was subjected to water hammer loads and absorbed much of the water hammer energy, whereupon the bonnet studs yielded and the gasket was forced outward against the studs. The failure of the gasket relieved much of the internal pressure, thereby minimizing damage to other equipment and valves at this station. Valve FCV-457 did incur damage to the flow actuator yoke and a bent valve stem.

Failure of the yoke of FCV-457, the loop B feedwater regulating valve, was probably due to lack of sufficient support or bracing of the valve operator during the pipe movement caused by water hammer loading.

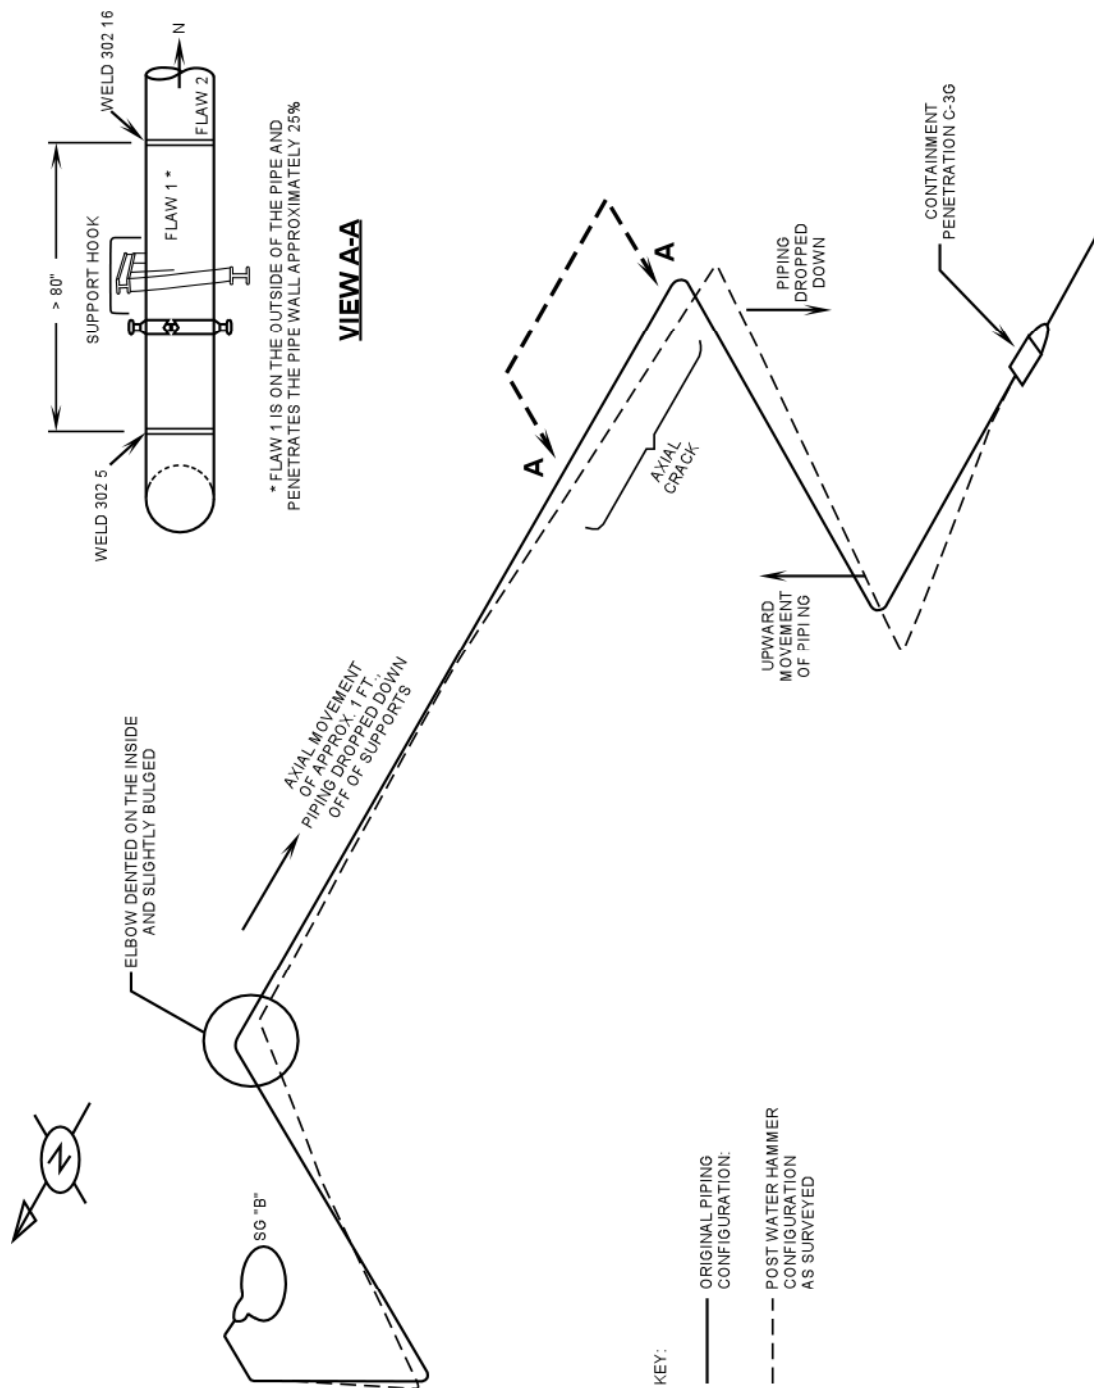
Figure 7.3-10 Overview of Feedwater Piping and Support Damage Due to Water Hammer

Damage to the loop B FW piping was confined to plastic yielding of the northeast elbow and to a visible crack on the outside of the pipe, extending approximately 80 inches axially. The crack penetrated approximately 30 percent of the pipe wall at its deepest point from the outside and approximately 25 percent on average. Damage to supports was severe in some instances. This section provides a description of the damage visible after the FW piping insulation was removed.

Figure 7.3-9 shows the loop B FW piping layout and identifies the piping support stations where damage occurred. This figure also provides directional orientation and indicates piping dimensions. Figure 7.3-10 shows principal areas of damage and indicates how the pipe moved.

The water hammer forces were sufficiently large to damage pipe supports and piping and to transmit loads through the containment building penetration structure outward to the loop B feedwater regulating station. No damage was evident to the steam generator B feeding or nozzle region that can be attributed to water hammer, nor was there evident damage to or movement of the piping between support HOOC and the steam generator B feedwater nozzle. Table 7.3-1 and Figures 7.3-9 and 7.3-10 illustrate the piping and support damage.

<u>Support Locations</u>	<u>Description of Component, Damage, Motion. Etc.</u>
HOOC HOOB HOOA	This snubber station, the closest to the SG B, showed no visible damage or pipe movement. The feedwater pipe turns vertically, and at an angle, to rise approximately 10 feet to mate with the SG feedwater inlet nozzle.
HOOD HOO5 HOO6	These support stations were the first that showed damage (or movement) caused by water hammer. Dent in pipe that resulted when the pipe hit the concrete corner and then rebounded.
HOOG	Movement of approximately 12 inches, slippage of vertical support pads off channel beam structures and downward drop of FW pipe.
HOOH	Horizontal and vertical support pads displaced southward approximately 12 inches.
120	Evidence of first lateral motion (eastward); deformed vertical structure, and then axial rebounding which displaced pipe supports approximately 12 inches southward.
HOOK	Damage incurred at the support structure downstream of the southeast elbow. The damage incurred by the structure illustrates the magnitude of pipe motion which occurred during the water hammer pulse.

HOOL	Lateral movement (westward) of pipe which resulted in sheared vertical support structure. Concrete and support plate damaged by water hammer, nuts were loosened and bolts were missing in wall plates.
HOOM	Piping and support damage just downstream of where FW B line takes a 90-degree bend to exit the containment building.

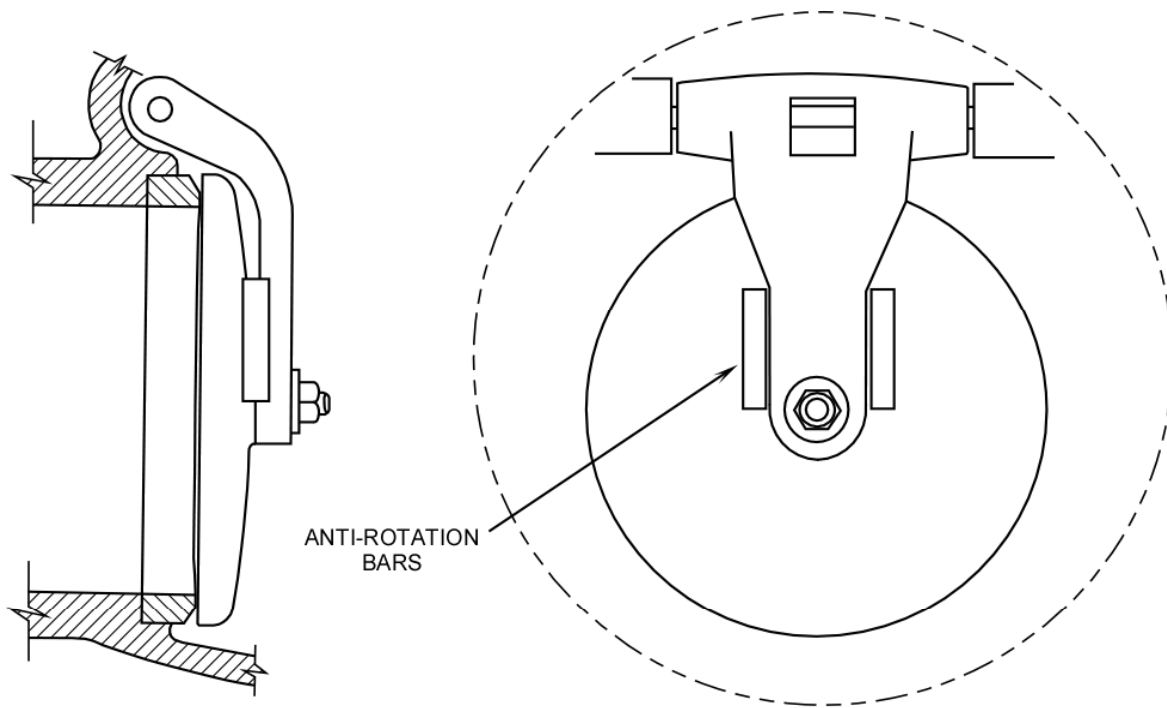
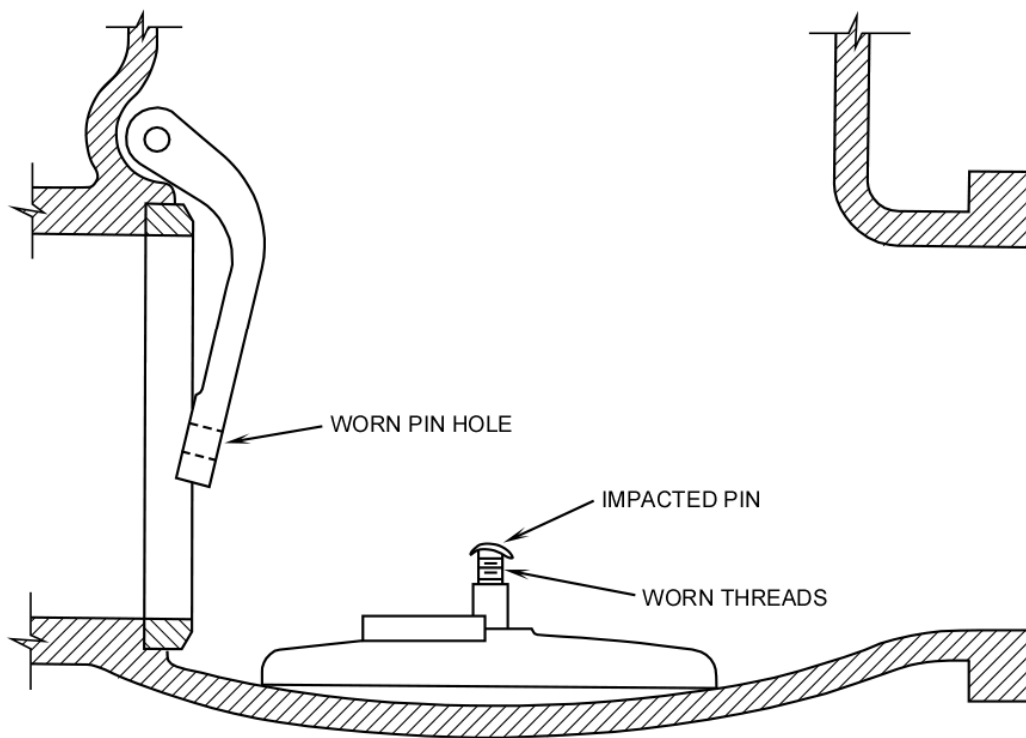
Figure 7.3-12 Check Valve FWS-346

Valves FWS-345 and FWS-346 failed the IST on February 24, 1985, when tested during mode 5 (cold shutdown). Maintenance work orders were prepared to repair both valves. However, on February 26, 1985, “Non-routine and Increased Frequency IST” was performed during mode 3 (hot standby), and the valves passed. During mode 3 the steam generator pressure increased the differential pressure available to seat the check valves (to approximately 700 psi) and thereby enabled them to pass. The work orders were then cancelled, and no corrective maintenance was performed.

The failure of FWS-346, the B feedwater header check valve, may have been caused by the inadequate hardness of the disc-attaching stud, which allowed the threads to strip and the end to mushroom over, conditions contributing to the ultimate valve failure. However, the service conditions (i.e., flow-induced vibration) experienced by this valve may also have been a major contributor to failure. The failures of FWS-345 and FWS-398, the A and C feedwater header check valves, may have been due to similar service conditions.

VALVE FWS-346 AS FOUND
